TRANSPORTATION RESEARCH CENTER

**Indiana University
Bloomington, Indiana 47403-1599**

ON-SITE AIR BAG INVESTIGATION

**CASE NO. - 96-16
FLEET - PRIVATE VEHICLE
LOCATION -
ACCIDENT DATE -**

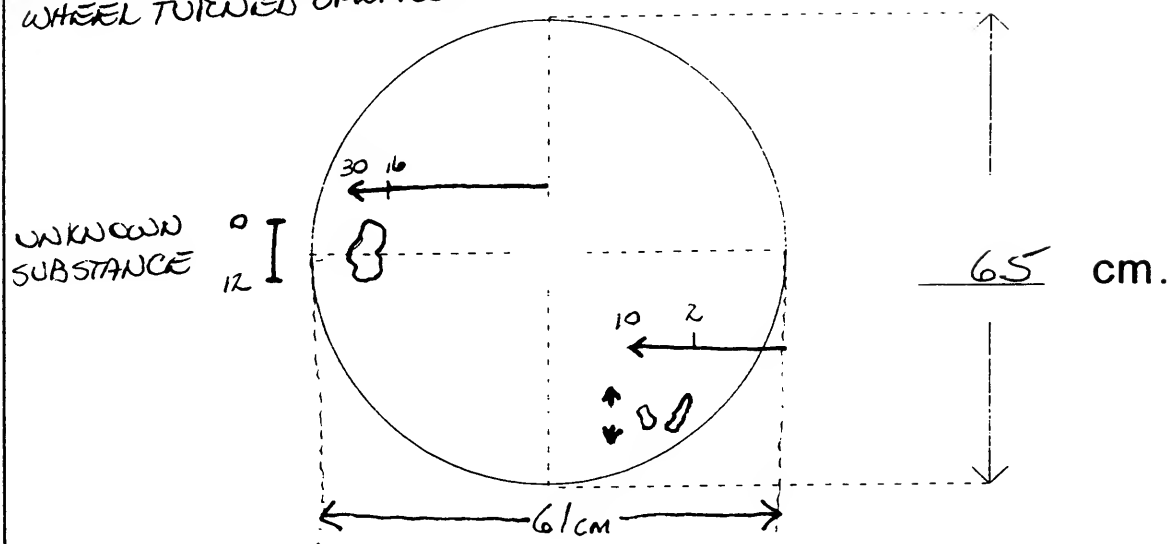
1. SKETCH DAMAGE AND CONTACT EVIDENCE ON DRIVER AIR BAG (Front)

MEASURED AS IF
WHEEL TURNED UPWARDS

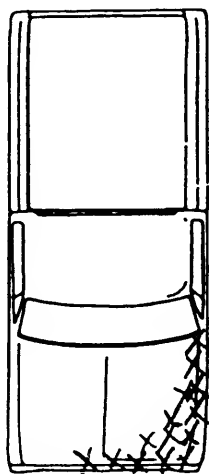
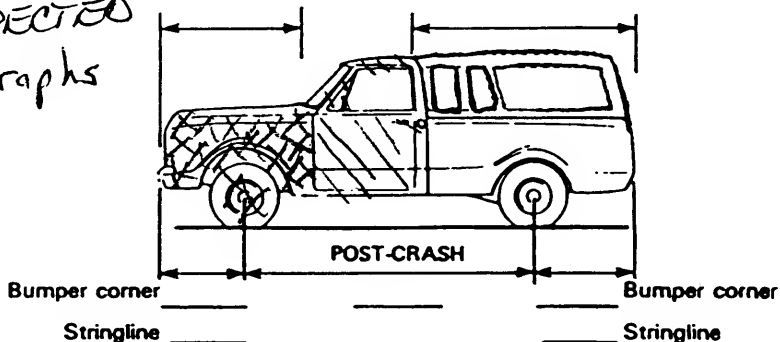
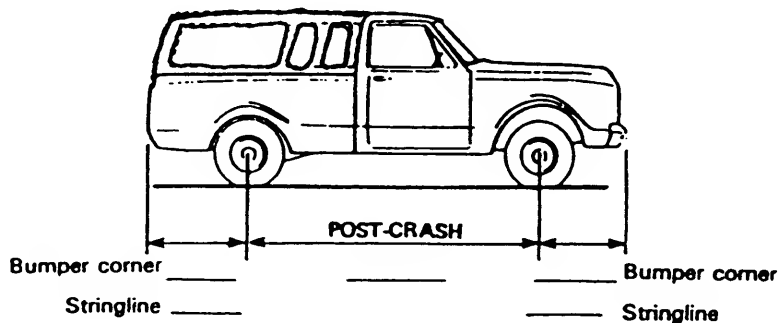
VEHICLE DAMAGE SKETCH

*VEHICLE NOT INSPECTED
 Damage per photographs

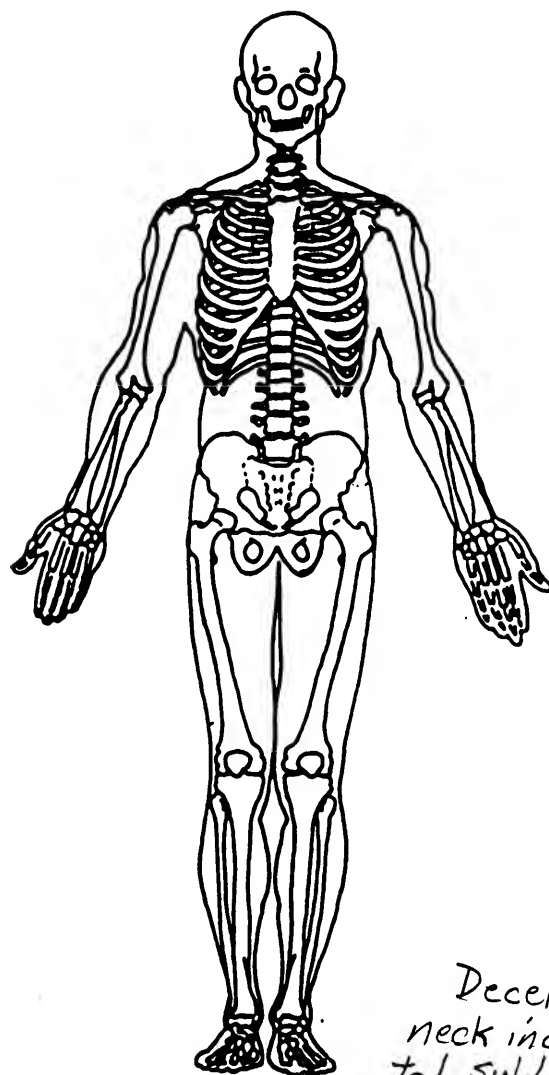
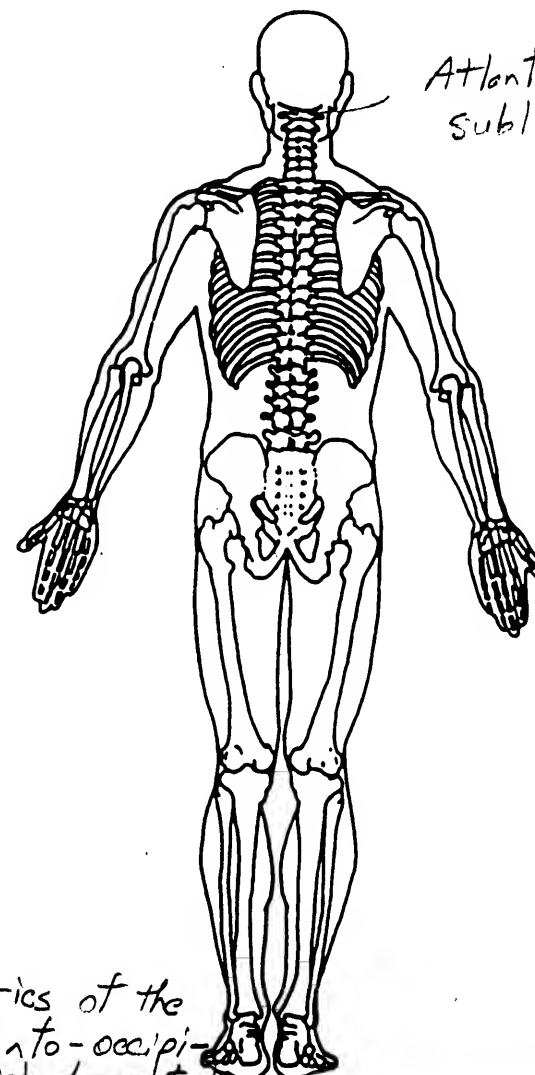
Autopsy

Atlanto-occipital
subluxation

Deceleration injuries of the neck including atlanto-occipital subluxation which lacerated the basilar artery causing the subarachnoid hemorrhage

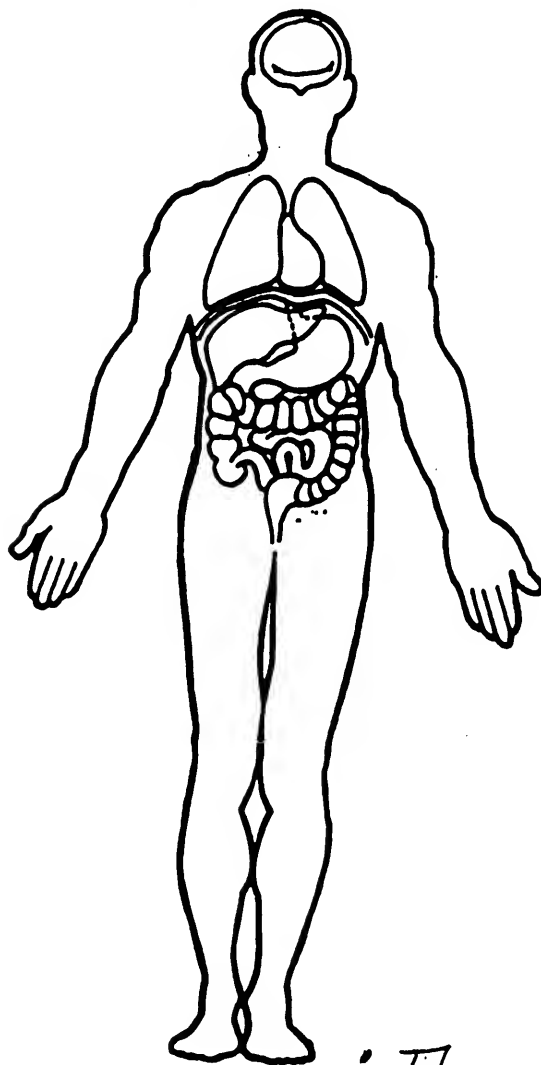
• Lacerated basilar artery at the level of the medulla caused by the subluxation

• Subarachnoid hemorrhage, 50 cc, resulting from laceration of basilar artery
